**Condition Report-**

Accession #s: 54.54.01a and 54.54.01b

**Collection:** URI HTCC

**Description:** 1880's Brown and tan two piece dress ensemble with brocade bib and tassels.

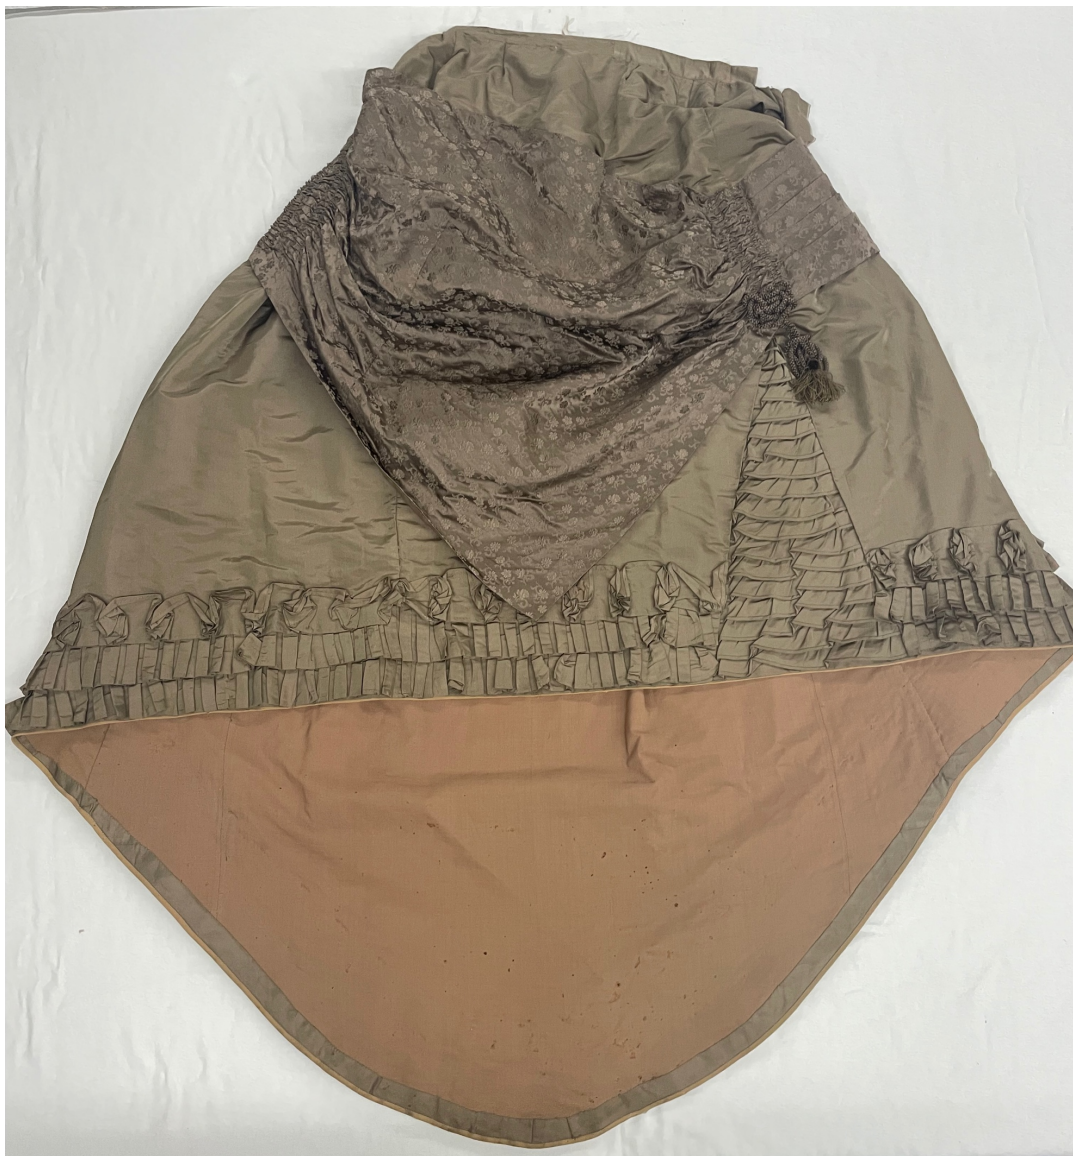
***Figure 1: Front Exterior of 54.54.01b skirt***

*-Front Exterior Skirt:* Overall good condition. The tacking stitches that hold the bib to the skirt are fragile/loose. The tassel on the front proper right side of the skirt is fraying a bit. Ruffles slightly flattened from storage,

Notable condition issues pictured include:

- Insect damage on interior of rear panel
- Slight flattening of ruffles from storage
- Some fraying at hemline
- Fraying at waistband
- Fraying of decorative tassel
- Fragile tassel attachment

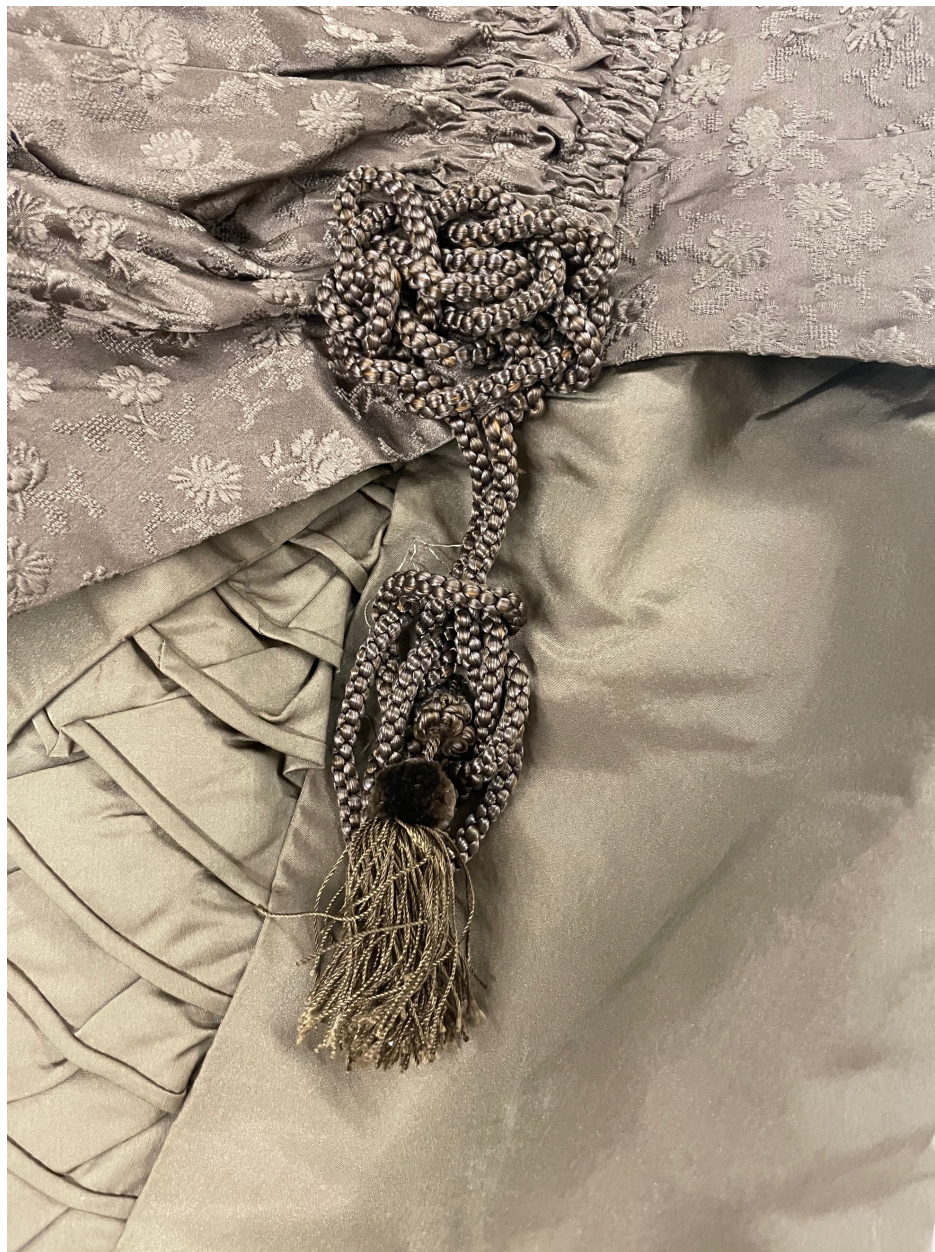
***Figure 2: Close up of front exterior of 54.54.01b skirt***

Notable condition issues pictured include:

- Fraying of Tassel
- Fragile attachment of tassel

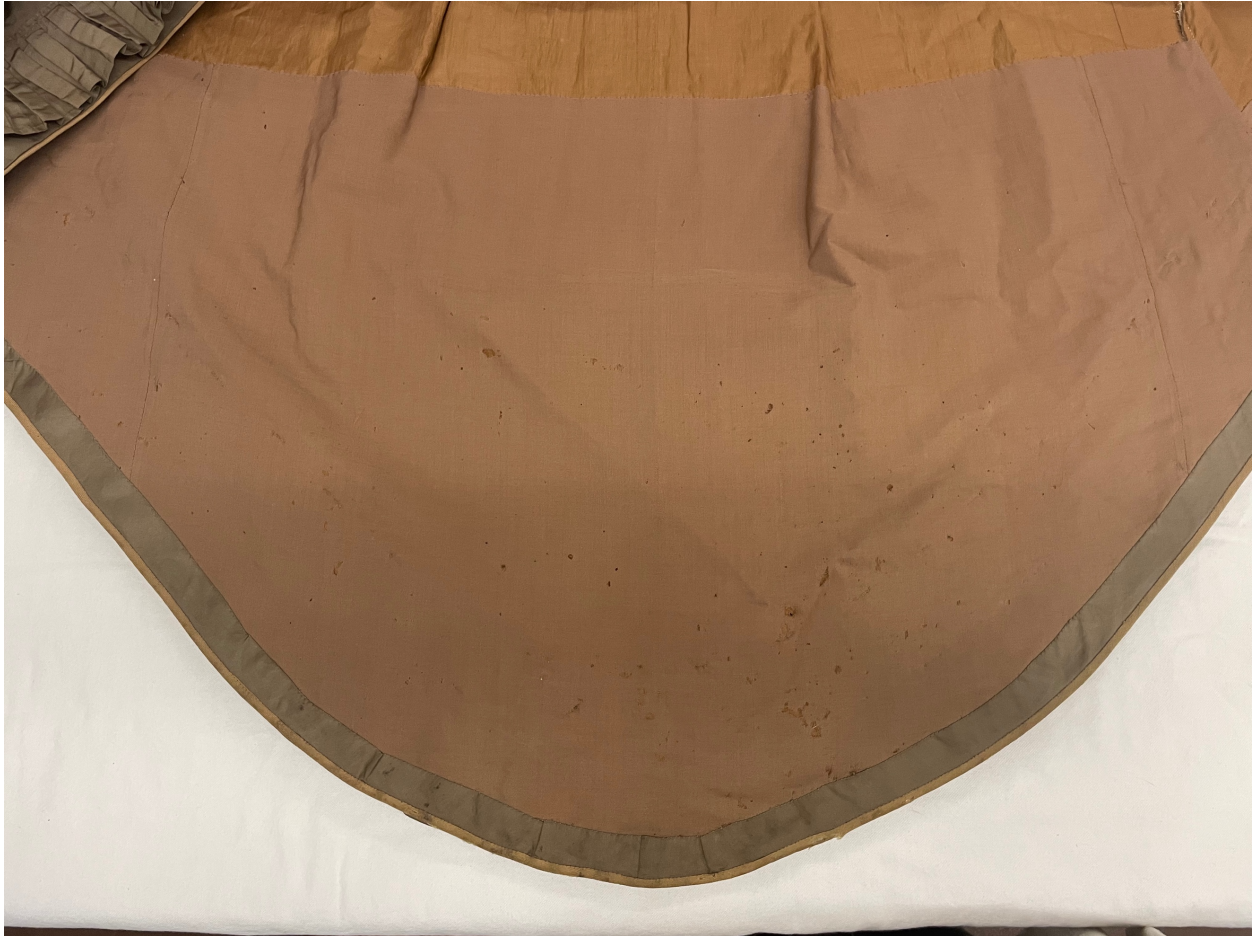
***Figure 3: Close up of Rear interior panel of 54.54.01b skirt***  
Notable condition issues pictured include:

- Notable insect damage
- Fraying at hemline

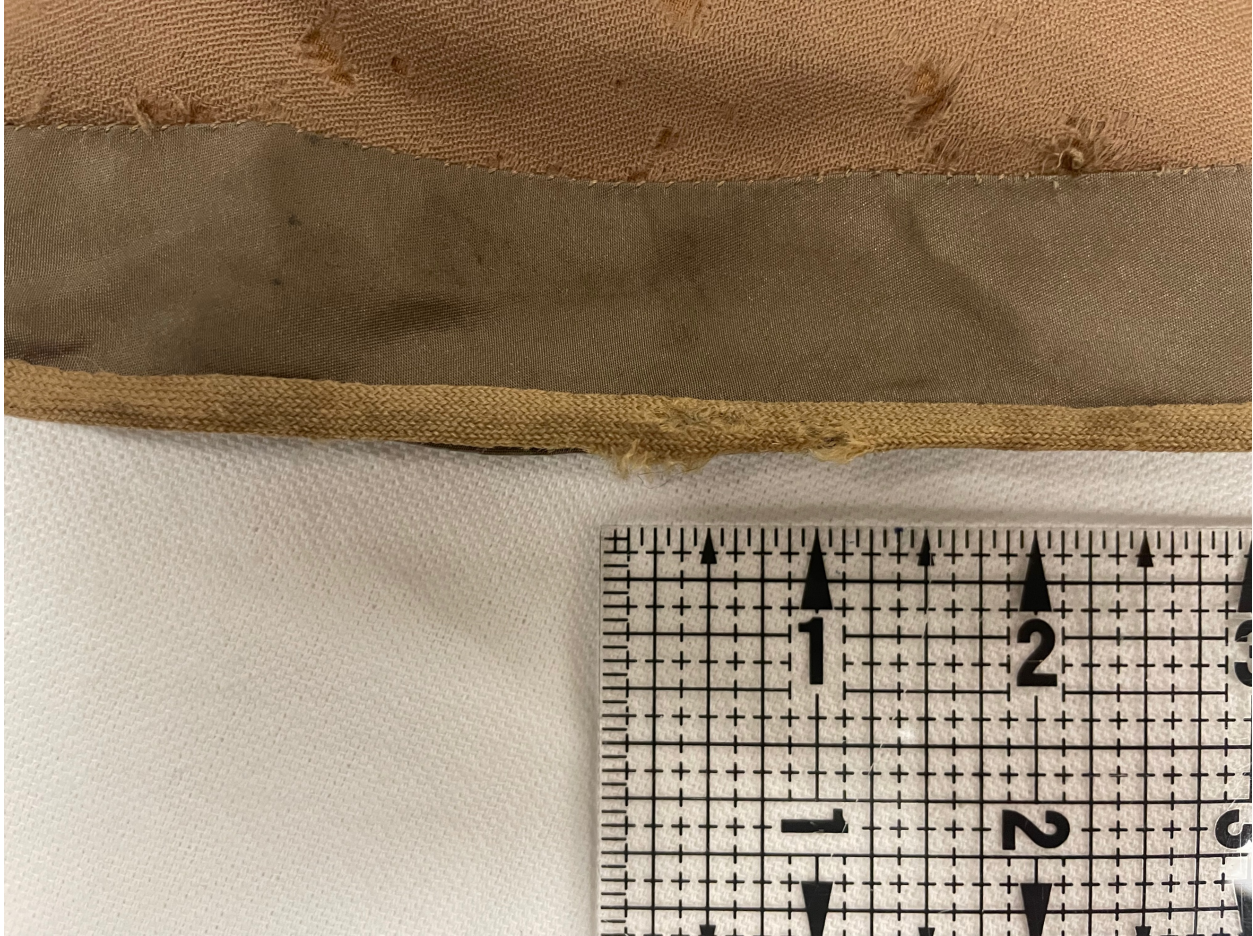
***Figure 4: Close up of Rear interior hemline of 54.54.01b skirt***

Notable condition issues pictured include:

- Notable rip/fray about 1"
- Insect damage

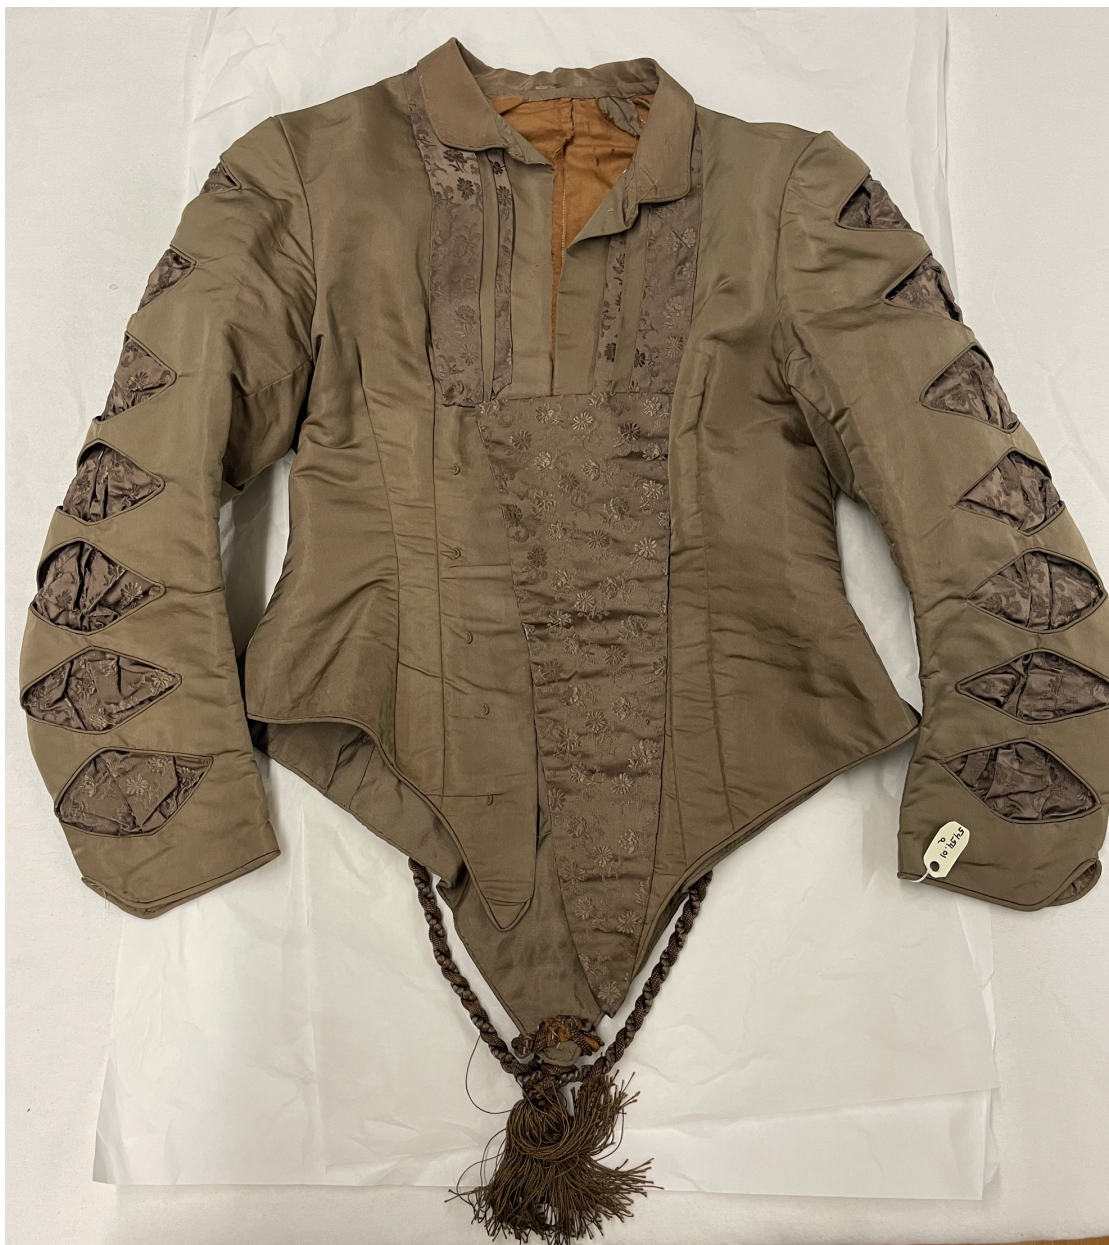
***Figure 5: Front exterior of 54.54.01a bodice***

*-Front Exterior Bodice:* Overall excellent condition, only visible damage is small sweat stains in the armpit areas and some wear/discoloration around the collar.

Notable condition issues pictured include:

- Slight perspiration staining under the armpits
- Slight discoloring by the collar

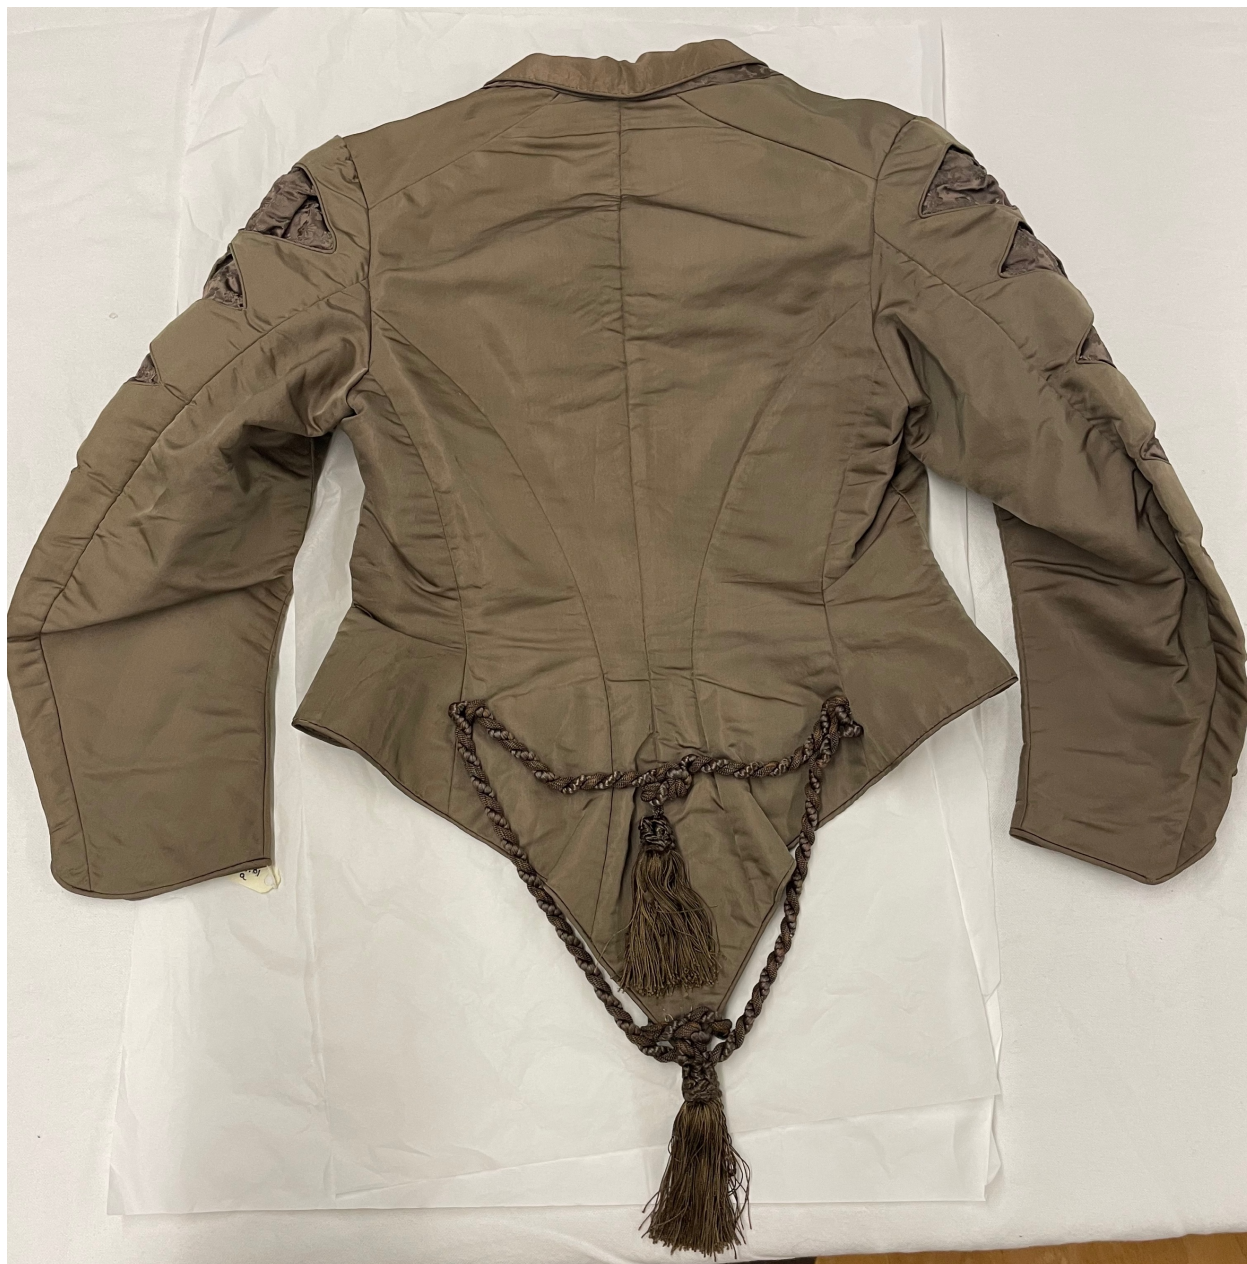
**Figure 6: Back exterior of 54.54.01a bodice**

*-Back Exterior Bodice:* Some wrinkling from storage and some discoloration by the collar.

Notable condition issues pictured include:

- Slight discoloration at collar

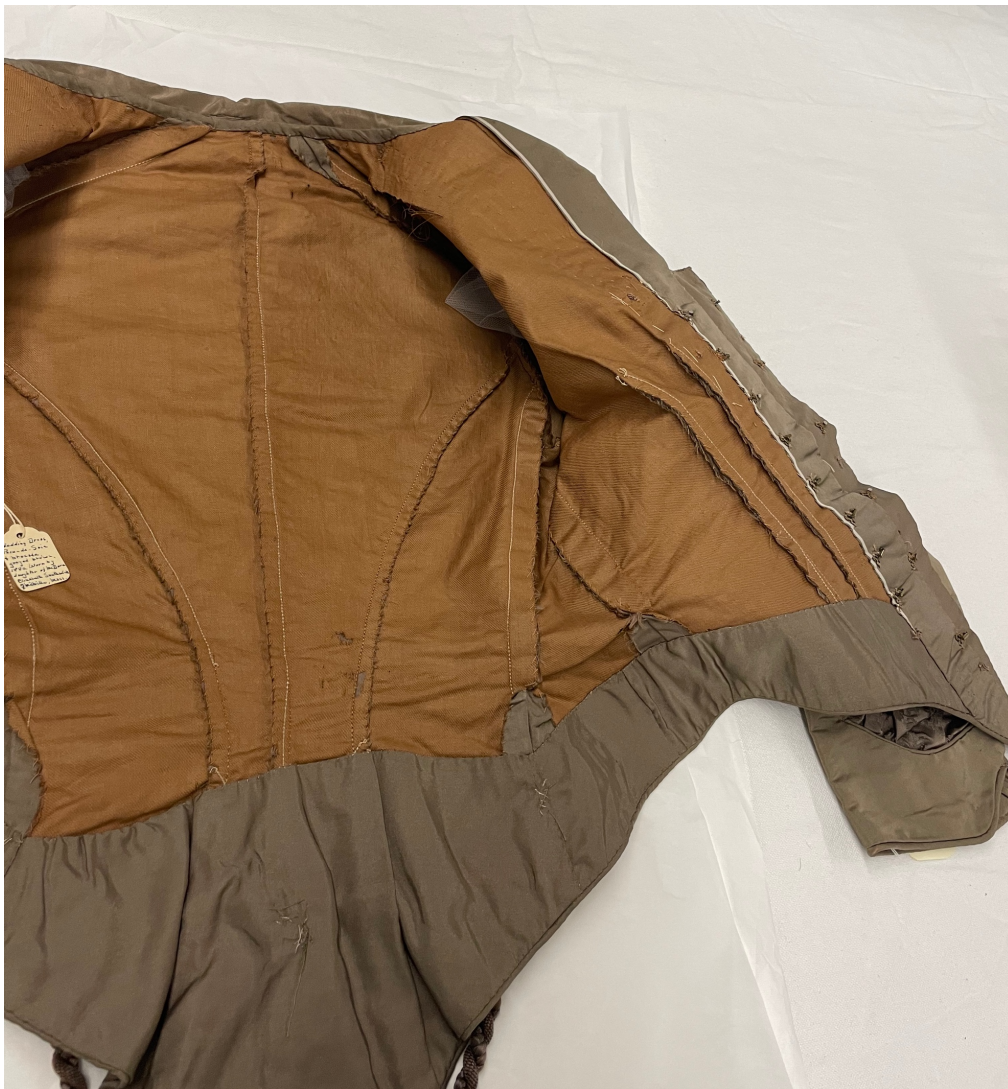
***Figure 7: Back interior and proper left front interior of 54.54.01a bodice***

*-Back Interior Bodice:* Some insect damage on lower proper left panel and upper proper left panel.

Notable condition issues pictured include:

- Insect damage on lower proper right back panel
- Insect damage on upper proper right back panel
